DEGRADATION OF HUBBLE SPACE TELESCOPE METALLIZED TEFLON® FEP THERMAL CONTROL MATERIALS

Patricia A. Hansen, Jacqueline A. Townsend NASA/Goddard Space Flight Center Greenbelt, Maryland 20771

ABSTRACT

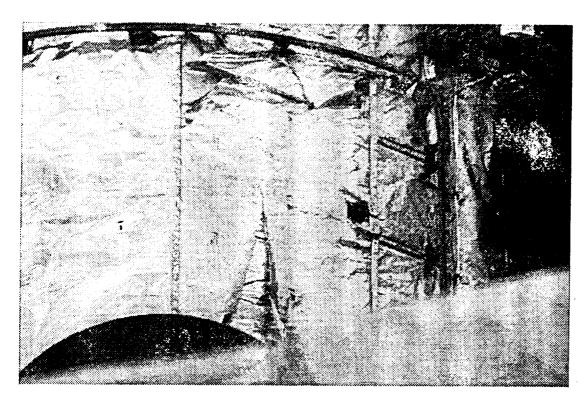
5.1 On-Orbit During the HST SM2, damage of the MLI was observed on the +V3 side (sun side) with several large cracks in the light shield MLI outer layer (above the stowed High Gain Antenna). This large crack is shown in Figure 3. Upon further visual observations of the vehicle, additional cracks were seen on all MLI surfaces. Cracking of the MLI outer layer was seen all over the telescope, with the most damage seen on the LS, SSM Bay 8, SSM Bay 7, and SSM Bay 10. The SSM Bay 8 is shown in Figure 4; the MLI is cracked around most of the bay perimeter, and the MLI appears as though it is partially detached and lifted away from the telescope.

Figure 3: Light Shield MLI Cracks

Although the damage to the MLI was visually dramatic, there was no measurable thermal effect due to the cracks and the exposure of the DAK to the telescope environment. However, during the SM2 mission, a program decision was made to reconfigure flown MLI patches to patch the worst of these damaged areas.

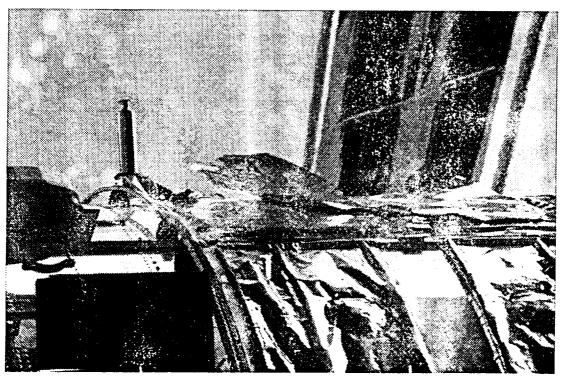
Prior to patching the corners of the SSM Bay 8 MLI, the astronauts performed two tests: a Velcro® cycling and Teflon® FEP bend test. The Velcro®, attaching the MLI blanket to the bay, was cycled to determine its integrity – was it still attached to the telescope substrate and did the hook still hold the pile securely? The astronauts reported that the Velcro® appeared to be securely fastened to the vehicle substrate and the hook seemed to hold the pile securely. The astronauts also bent a piece of the Teflon® FEP over on itself to determine if manipulating it during the patching process would cause significant damage. The astronauts reported that the Teflon® FEP did not crack.

Figure 4: SSM Bay 8 MLI Crack

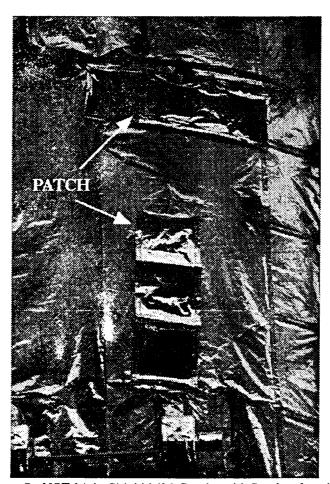
Figure 7: HST Light Shield MLI Cracks with Patches Installed

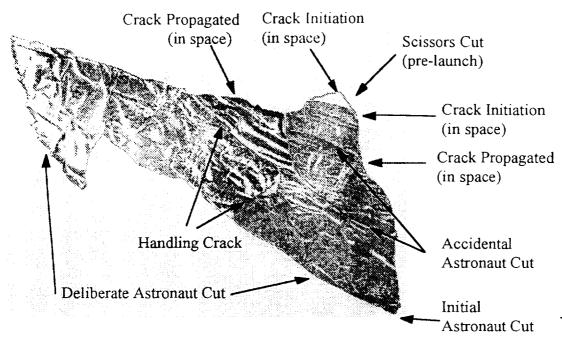
Figure 8: SM2 Teflon FEP

Sample
